February 20, 2012

HOME INSPECTION REPORT

XXXX Avenue

Livingston, NJ

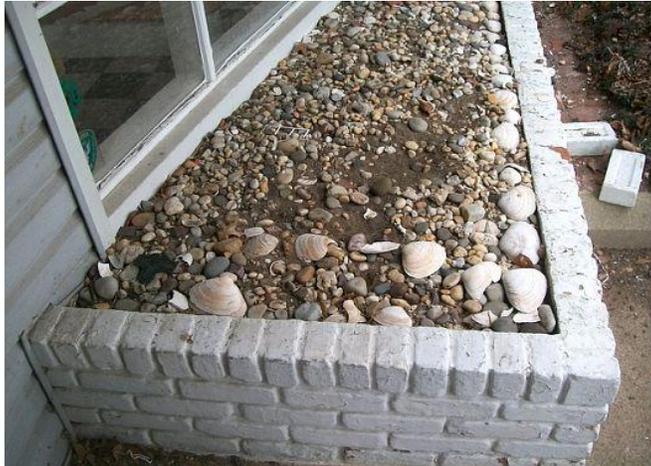
Front: **Inadequate due to presence of soil filled planter at front in contact with the side of the home.**

Soil filled planter at the front

- **Have the soil filled planter at the front removed or modified to eliminate soil contact with wood trim and structure.**
- **See Roof Drainage System section.**

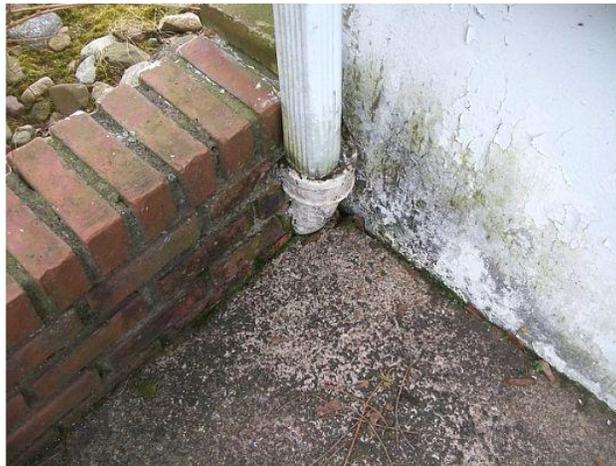
- **Many downspouts discharge into what appears to be older terra cotta clay underground drain pipe. This type of old pipe is often found to be clogged and / or broken underground, and can allow water to accumulate in soil around the home.**

Old underground pipe

- **Direct any above ground downspout discharge points as far away and downhill from the base of the home as is practical.**
- **Have the roof drainage system cleaned and maintained on a regular basis by a qualified gutter maintenance company. This includes periodic flushing and checking of any buried drain pipes into which downspouts may discharge.**

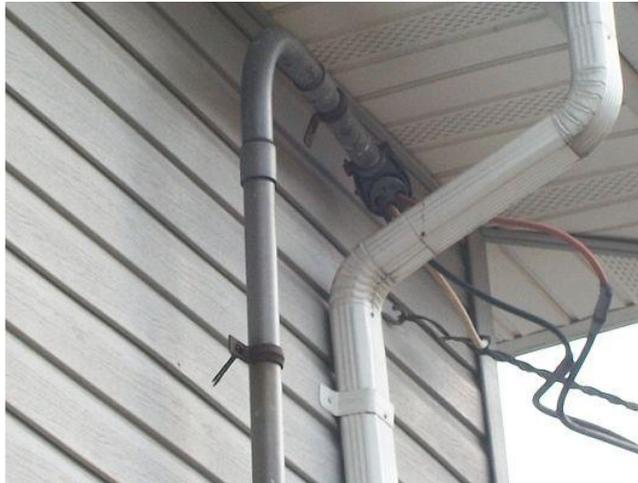
Service Entrance Location & Condition: Overhead feed. **The service cable conduit has detached from the side of the home and this is a potential hazard.**

Service entry conduit detached from the home

- **Have a licensed electrician upgrade capacity to 200 amperes replacing the service panel as required.**
- **Re-secure the entrance cable conduit to the house.**
- **Have a licensed electrician install functional GFCI electrical receptacles in all wet areas of the home including kitchens and bathrooms that lack them.**
- **Have a licensed electrician further evaluate fabric sheathed cable for adequate grounding and any other conditions, and upgrade grounding or replace cable as necessary.**

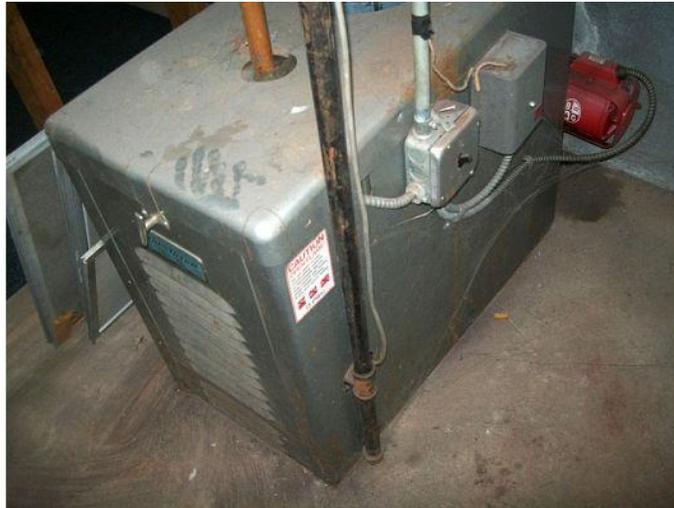
- **The heating components are far past the end of designed service life, and remaining service life is undeterminable by us. In addition, for old equipment, the possibility of hidden internal functional and safety related defects is significantly increased.**
- **Radiators and steam or circulated water pipes are older, and the need for increased maintenance and repair to these older components should be anticipated.**

Very old heating system boiler and associated components

- **Replacement of this old heating system with new equipment. This work should be done by a qualified and licensed heating contractor.**
- **Monitor radiators and radiator connections for leakage, and have any leaks repaired promptly.**
- **A service contract to cover future maintenance and repairs to the heating system.**
- **See the Chimney section of this report for more information.**

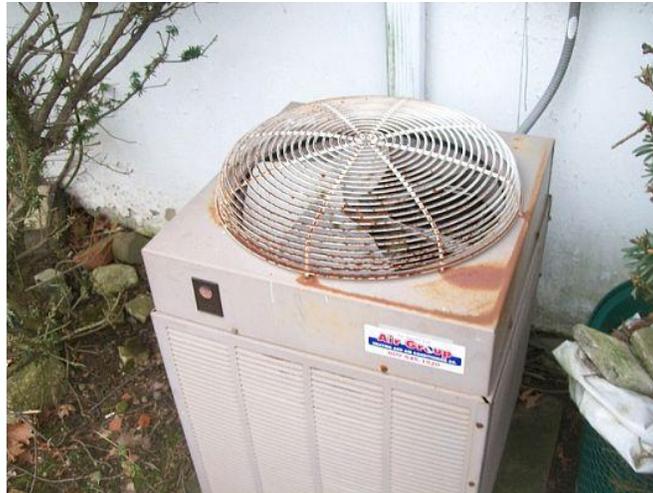
- **Aging, with visible corrosion.**

Aging AC equipment

- **Have the AC systems serviced and maintained by a qualified HVAC tech prior to closing on this property, and annually thereafter.**
- **Plan for replacement of the AC equipment during renovations to this home.**

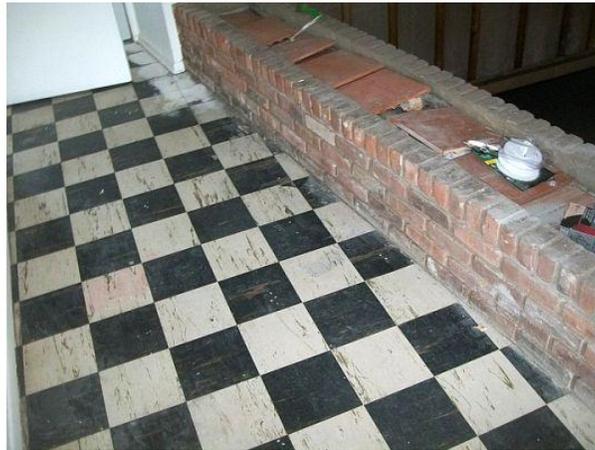
Old floor tile in the entry hall appears to be a type that may contain asbestos.

Old floor tile likely contains asbestos

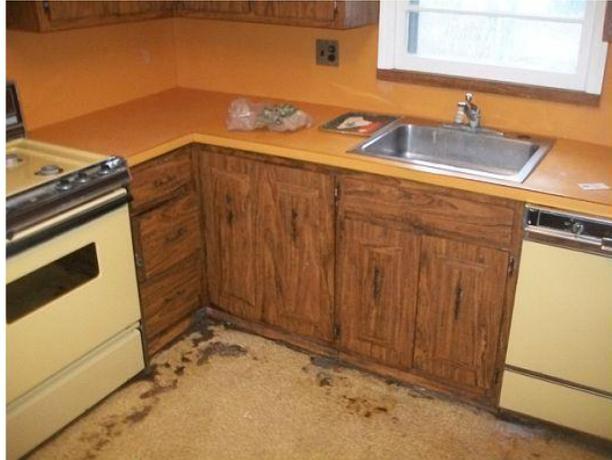
Kitchen cabinets and countertops are in very worn condition.

The kitchen is old and worn
