October, 2010

SAMPLE HOME INSPECTION REPORT

Address Redacted for Privacy

Maplewood, NJ

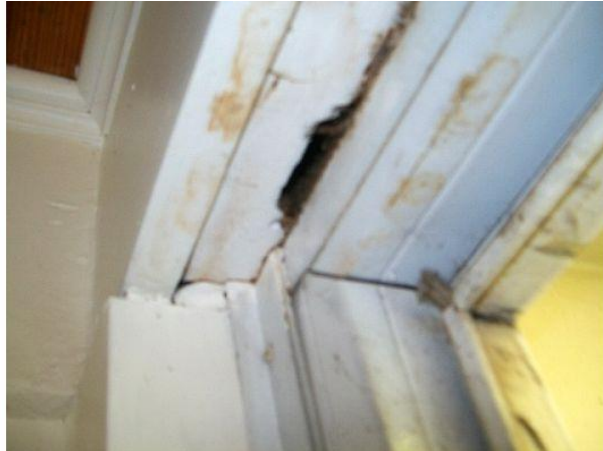
Condition: **Worn floor surface, and also water and carpenter ant damage to the**

upper perimeter wood framing and trim.

Water and ant damage to perimeter wood at enclosed patio room

- **Repair or replace water and ant damaged wood.**
- **Maintenance and repair to floor surface as desired.**

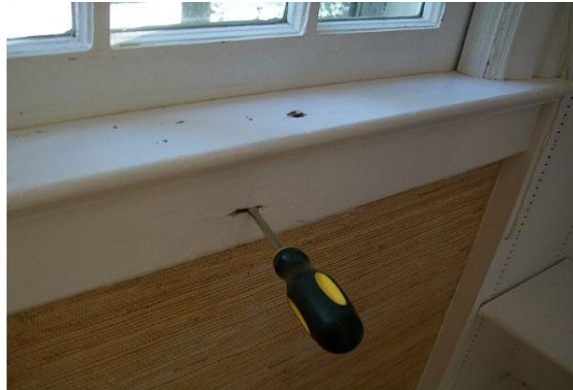
- Generally functional in most areas.
- **Carpenter bee damage is present to upper rear trim.**
- **Carpenter ant and water damage is present to patio room trim at the right front.**
- **Termite damage is present to left side interior window trim and sills.**

Termite damaged interior trim

- **Have a qualified contractor repair worn, water damaged and insect damaged sections of trim and siding. Further evaluation is needed to determine the full extent of damage and repairs needed.**
- **See the separate wood destroying insects report from Terminite, Inc.**

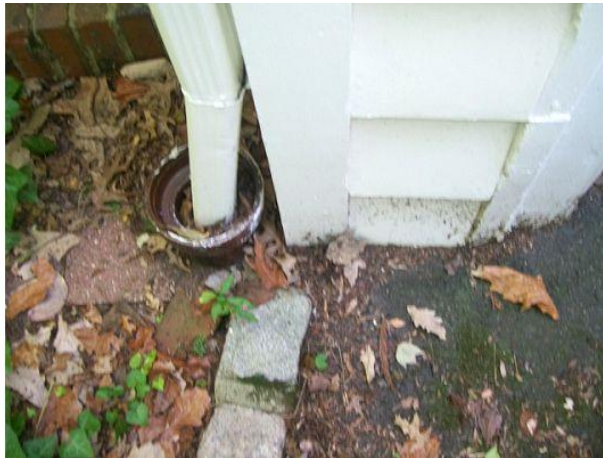
- **Many downspouts discharge into what appears to be older clay underground drain pipe. This type of pipe is likely clogged and / or broken underground, and can allow water to accumulate in soil around the home.**

Old clogged underground clay pipe

Inadequate or defective roof drainage systems, if present, can lead to damage from water entry into the walls and other structural components, and water entry into the basement.

- **Have old underground drain pipe replaced, or abandon and discharge above ground and away from the base of the home.**
- **Direct all downspout discharge points as far away and downhill from the base of the home as is practical.**
- **Have the roof drainage system cleaned and maintained on a regular basis by a qualified gutter maintenance company.**

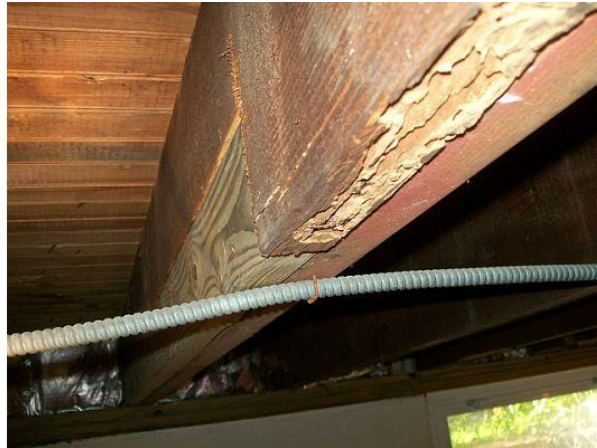
- **Termite damage is present to a section of sill plate at the left rear.** (Sill plates along the left side have been replaced).
- **Termite damage is present to several floor joists/beams along the left side, and repairs are not adequate. One doubled floor joist/beam has damage to both sections of this structural member. Another damaged joist has been only partially sistered with new lumber (the bottom edge).**

Termite damage to a floor joist with only partial & inadequate repairs.

- **See the separate wood destroying insect report for more information relating to the wood framing of this home. Since evidence of wood destroying insect infestation was found, then be aware that further evaluation would be required to assure that hidden damage to structural members is not present.**
- **Have a qualified contractor familiar with wood destroying insect damage repair further evaluate the home to determine the full extent of wood destroying insect damage, and make repairs or reinforcements as necessary to ensure long term structural stability. This should include re-work and proper reinforcement of inadequate floor joist repairs already done by others.**

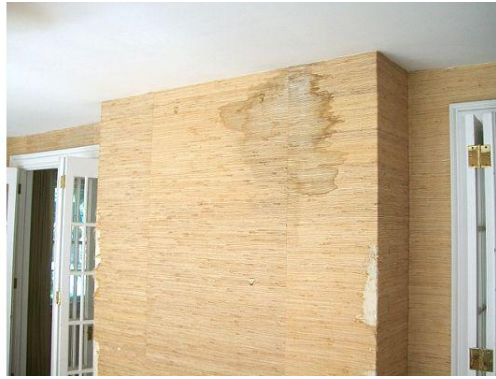
- **Roof shingles appeared to be worn in some areas, with eroding mineral particles.**
- **Some roof flashings may be older than the currently installed roof. Leakage is more likely to occur around old flashings.**
- **Signs of leakage through the roof are clearly visible at the interior, around the chimney.**

Leakage staining around chimney on the interior

- **Have a qualified roofer further evaluate the roof for wear and / or leakage, and make repairs or replacements as necessary to ensure long term leak free condition.**
- **See Chimney section.**
- **Have a qualified roofer evaluate the upper roof and perform maintenance as necessary – flat / low sloped roofs generally require annual maintenance.**

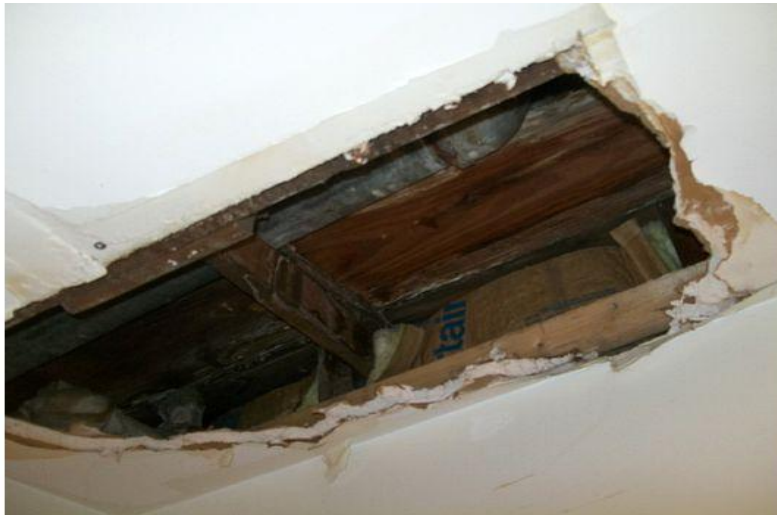
Wall and Ceiling Condition: **Wear, light damage many areas, water staining around chimney, and a large opening broken out of the ceiling at the rear of the kitchen.**

Hole in kitchen ceiling

Leakage appears to have occurred from a second floor bathroom into the ceiling of the kitchen.

- **General complete interior renovation, refinishing and damage repairs throughout the home.**
- **See Roof, Chimney and Bathroom sections – ensure that repairs are adequately made to prevent future water damage.**

- **See Plumbing section.**
- **Have a plumber determine reason for low water pressure in the second floor main bathroom shower, the cause of the leakage that damaged the kitchen ceiling, and make repairs or replacements as necessary.**
- **Plan for general repairs and replacements to aging bathroom fixtures and plumbing.**
- **See Electrical section.**

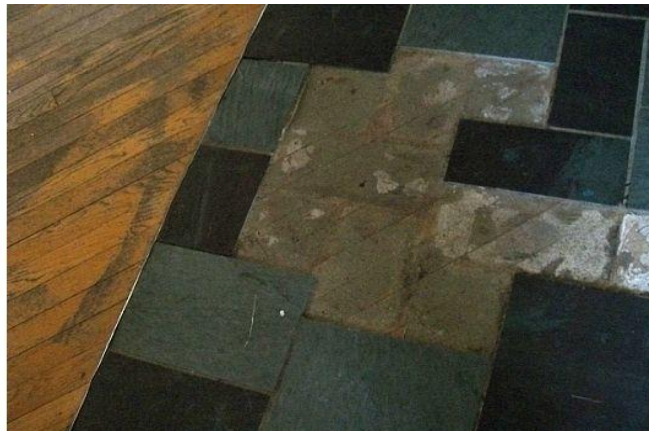
Floor Condition: **Significant wear is present in many areas, including on wood floors. Loose slate tile is present in the front entry hall.**

Loose slate in entry hall

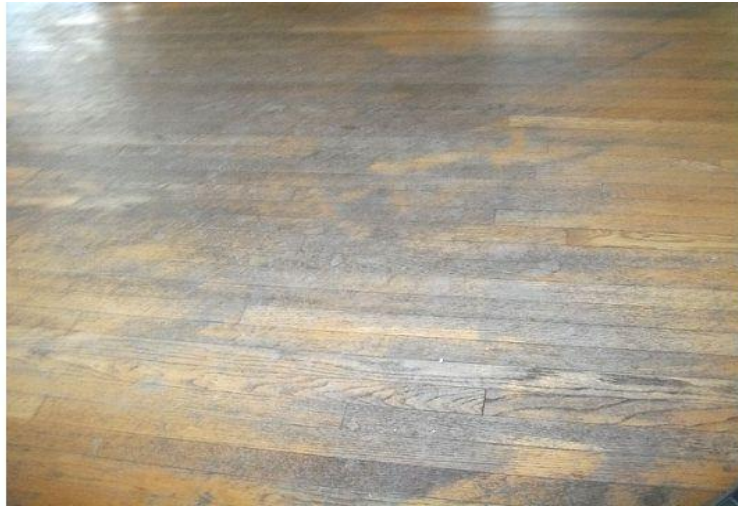
Worn & stained wood finish flooring

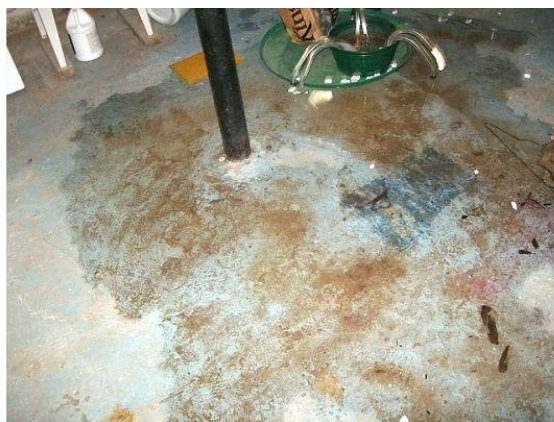
- **Signs of prior water entry were found to be present.**
- **Water was present on the basement floor on thd date of inspection.**

Water on the basement floor

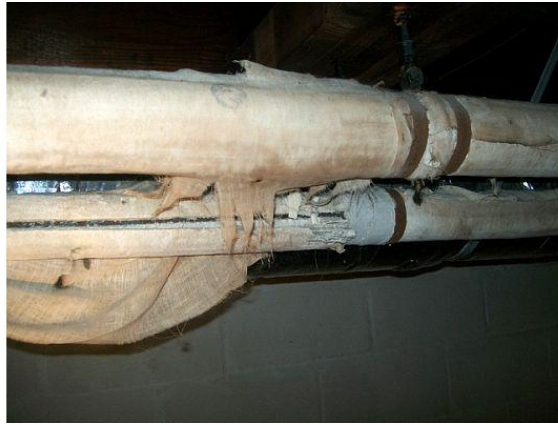
Insulation material suspect of containing asbestos is present on some sections of steam pipes in the basement.

Pipe insulation likely to contain asbestos

Recommendations: Further evaluation and testing done by specialists for your protection.
