August 24, 2012

HOME INSPECTION REPORT
Multi-Family Sample Avenue
Northern, NJ

Multi-Family, Northern, NJ

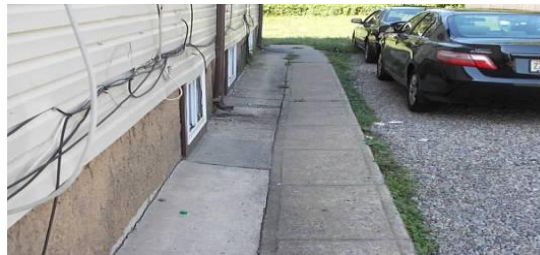
- **Adverse, due to lack of maintenance to the roof drain system.**
- **Adverse, due to hard surfaces in some areas settled / sloped towards the home.**

Hard surface paths sloped towards the home

- **See Roof Drainage System section.**
- **Inquire with legal counsel regarding the need for flood insurance.**
- **Have the areas immediately adjacent to the home graded away from the home, including having hard surface paths removed or re-set.**

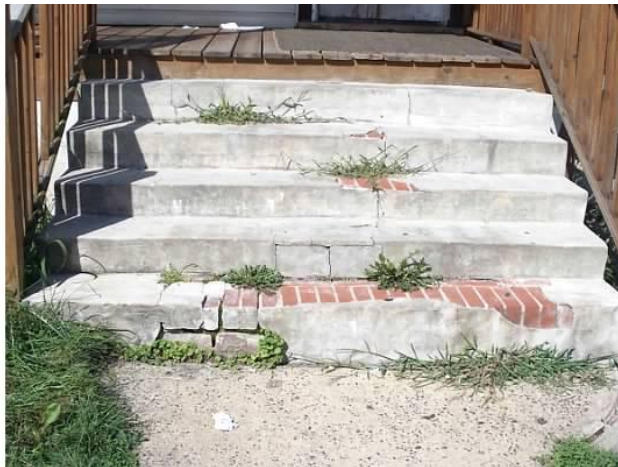
Front Entry Area: Wood porch, with two sets of masonry steps. **Significant wear is present on both the masonry steps and front porch itself.**

Worn steps

- **Have the left side door repaired or replaced.**
- **Have a qualified mason / contractor repair or renovate entry steps and front porch as necessary to ensure a safe condition.**

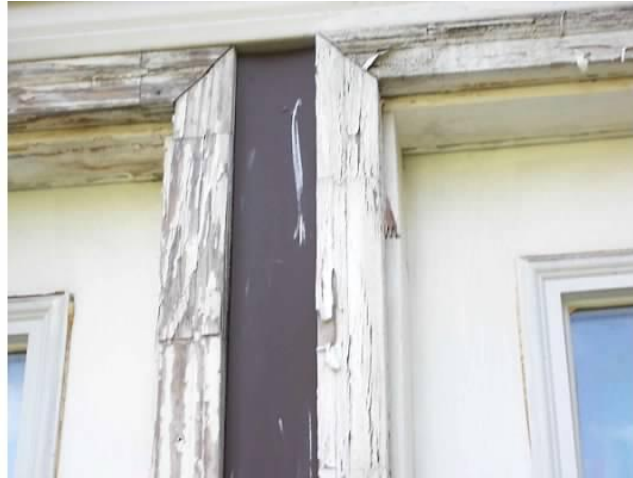
- Most broad areas of siding are in generally functional condition.
- **Some graffiti is present on the rear exposure.**
- **Wood trim around doors and windows is generally very worn, with deteriorated wood and peeling paint.**

Worn wood trim

- **Have a qualified contractor remove the graffiti.**
- **Have a qualified contractor replace, repair and / or repaint deteriorated areas of wood trim.**

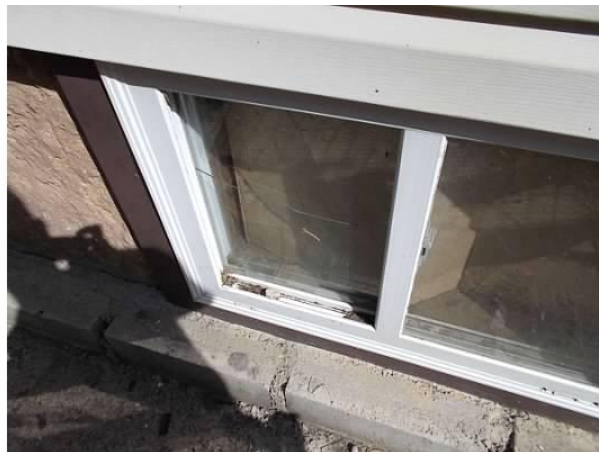
- Most tested windows were found to be in functional condition on the date of inspection.
- **Several basement windows have broken glazing.**

Broken basement window glass

- **Use of window guards on all windows above the first floor level.**
- **Have all broken window glazing replaced.**

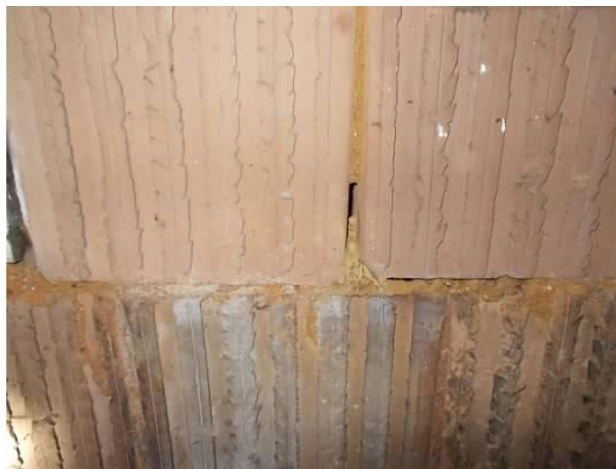
- **Sections of loose and / or missing mortar are present between terracotta blocks, particularly at the front walls.**

Gaps and soft mortar in terracotta block

Note: Terracotta clay tile is a low strength material no longer used for structural supports and foundation walls. Because of its low strength it is more prone to develop defects and can be easily damaged by impact.

- **Have a qualified mason familiar with older terracotta block foundation walls re-point / maintain the foundation walls to extend life and assure structural adequacy.**

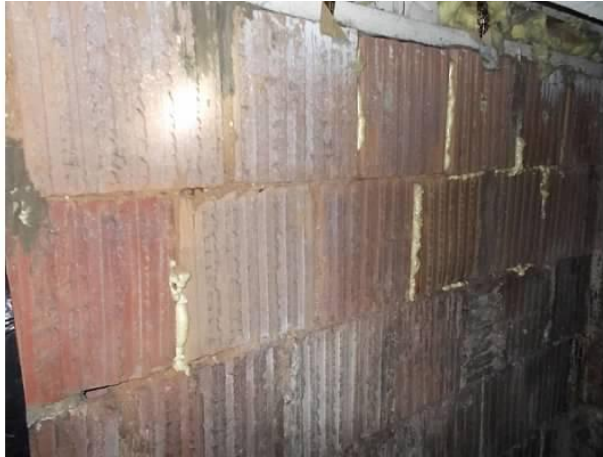
- **Some gaps have been filled with expandable spray foam. This is not a**

structural repair and is not adequate.

Spray foam between blocks

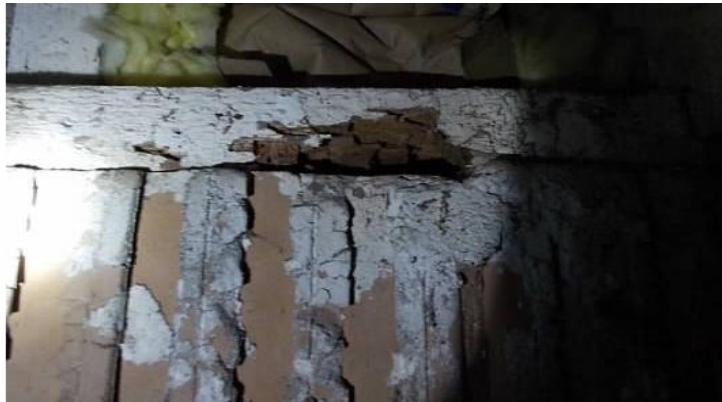
- **Termite and powder post beetle damage is present to sill plates along the back section of the structure.**

Powder Post Beetle damage to sill plate

- **Have a qualified contractor familiar with wood destroying insect damage repair further evaluate the structure to determine the full extend of wood destroying insect damage and make repairs or reinforcements as necessary to ensure long term structural stability.**

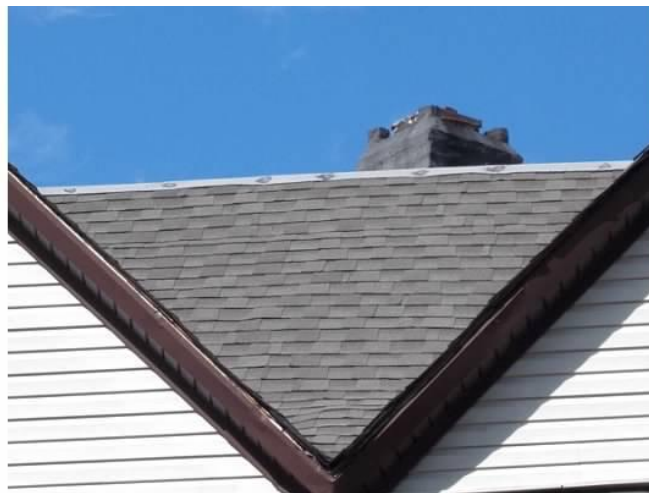
- **Most areas of roof shingles appeared to have moderate wear.**
- **Signs of patching along ridges are present.**

Patching along roof ridge

- **Because of the adverse roof conditions noted above, I recommend that a qualified roofer further evaluate the roof to determine the full extent of wear and / or leakage, and make repairs or replacements as necessary to ensure long term leak free condition.**
- **Have a qualified roofer familiar with flat roofs perform annual roofing inspections and maintenance, and make repairs or replacements as necessary to ensure long term leak free condition.**

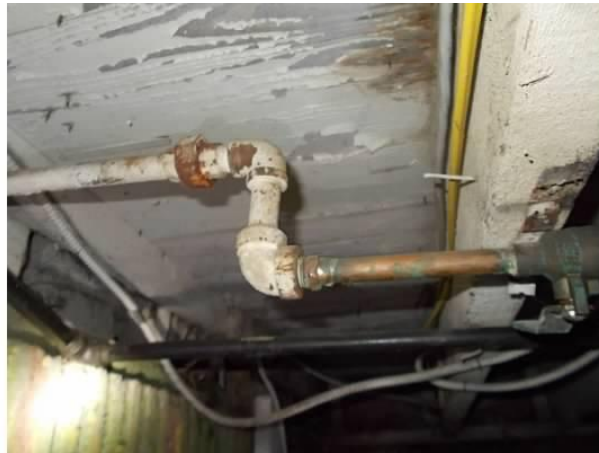
- **Some shutoff valves exhibit significant visible corrosion and signs of leakage.**
- **Remaining sections of old iron water supply pipe is now past the end of designed service life, and could leak or otherwise fail without warning.**

Old iron pipe attached to newer copper pipe

- **Have a plumber repair or replace water supply shutoff valves that exhibit visible corrosion or have signs of leakage.**
- **Have a plumber replace the remaining sections of old iron water supply pipe.**
- **Have a plumber replace drain pipe with significant corrosion and leakage.**
- **To determine the true condition of the waste and drain pipes we recommend that a plumber inspect them internally using a specialized video camera.**

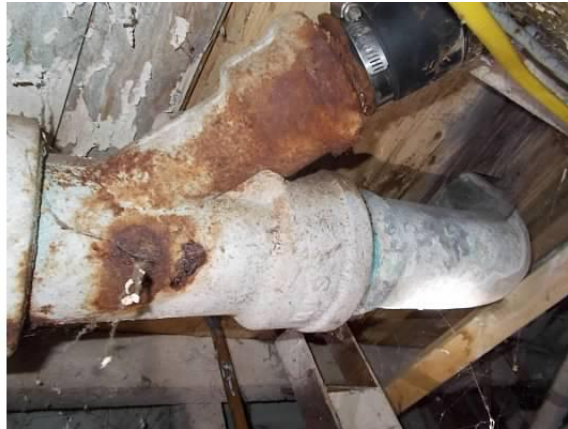
- **A number of sections of old drain pipes visible in the basement have very significant corrosion and have active leakage.**

Badly corroded and leaking drain pipe

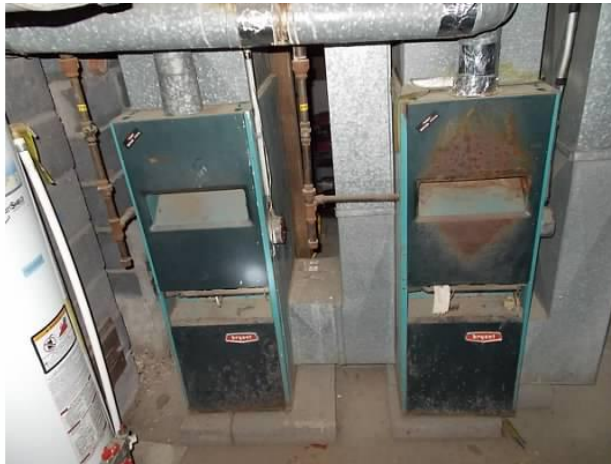
- **The heating systems are significantly past the end of designed service life, and remaining service life is undeterminable by us. In addition, for old equipment, the possibility of hidden internal functional and safety related defects is significantly increased.**
- **Significant visible corrosion present on all units, which suggests hidden defects, which may be corrosion and perforation of the internal heat exchangers, which would render the units unsafe to use.**

Two of the four heating systems

- **Replacement of these old heating systems with new equipment. Consider high efficiency, direct vent type units that do not use the masonry chimneys. This work should be done by a qualified and licensed heating contractor.**
