August 12, 2012

HOME INSPECTION REPORT

XXXX Avenue

Ridgewood, NJ

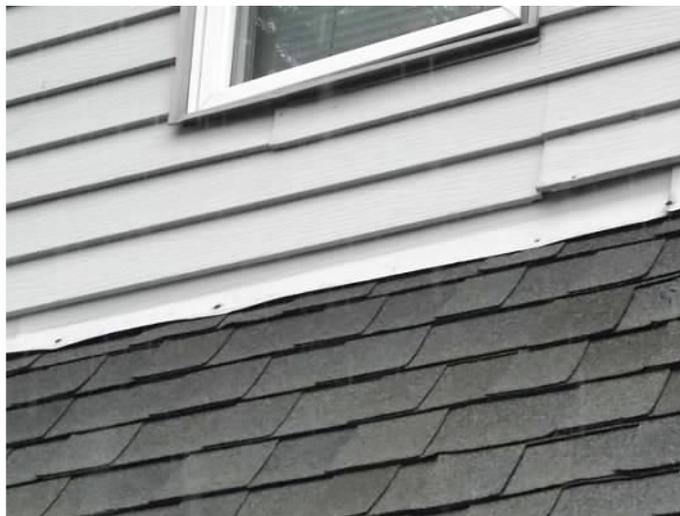
- Most areas of aluminum siding and brick are generally functional.
- **Basement window frames have been damaged by a wood destroying insect infestation.**
- **Lower sections of aluminum siding on the second floor level are inadequately attached where they meet the lower shingled roof.**

Poorly attached lower section of siding

- **Have the damaged window frames replaced along with basement window replacement.**
- **See Roof section – have the lower sections of second floor siding modified so that installation detail in this area conforms to accepted practice.**

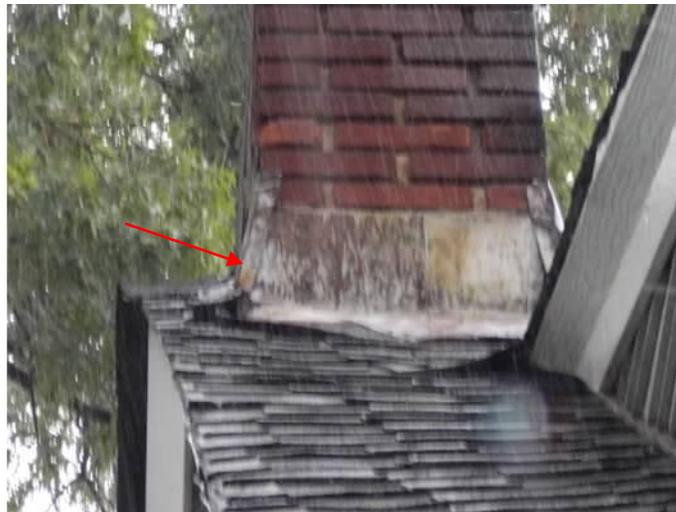
- **Chimney flashing installation is poorly done and does not conform to accepted standards. Leakage is more likely to occur around these inadequate chimney flashings.**

Poorly installed chimney flashings

- **The National Fire Protection Association and the National Chimney Sweep Guild recommend that, due to advanced age or other conditions such as visible exterior damage or modification to the heating system, a Level-2 Inspection of the chimney and internal components be done to rule out hidden potential safety defects, and we recommend this as well.**
- **Have a qualified chimney contractor service or repair the chimney as**

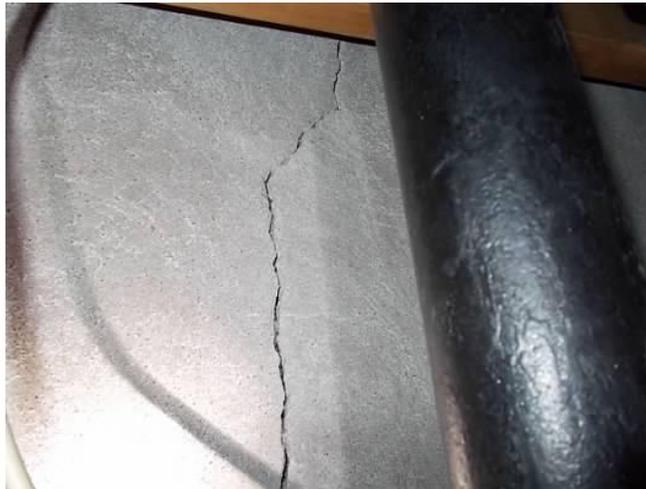
- After construction of a home soil compression sometimes occurs under the foundation wall footings, and this may result in cracks that are vertical, diagonal or stair-step in pattern. **Cracks of this type that are more than 3/16 inch wide or have other complicating factors such as wall displacement, or evidence of prior patching that has opened up, are not minor, and are considered to be structural defects in need of repair. Our home inspection found foundation wall cracks of the type and degree described above along the front wall, where a vertical crack is approximately 3/16 inch wide and has some displacement of wall sections.**

Vertical crack

- Adequately repair or replace structural framing that has been damaged by wood destroying insect infestation. This includes the beam end as well as adjacent sill plate and framing.
- The foundation cracks found appear to be moderate to severe. The type of defect found is often caused by poor water control and inadequate drainage around the home. We recommend that improvements to the exterior drainage system may reduce or eliminate worsening of these foundation defects, and we recommend that this be done. We also recommend further evaluation of the foundation walls and footings to determine the true cause of the defects, and reinforcement or repairs be done as required to assure long term structural stability.

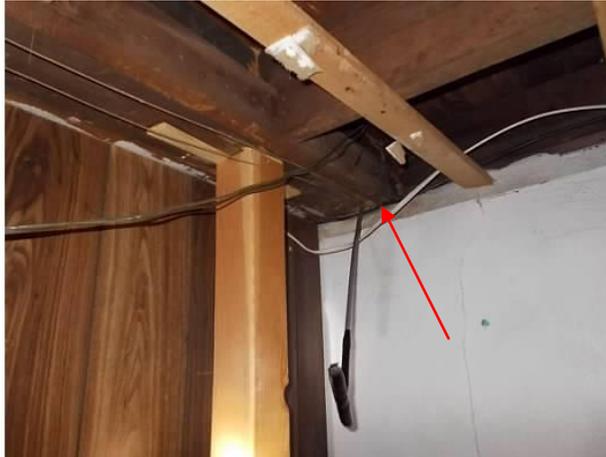
- **The front end of one main beam has been damaged by a wood destroying insect infestation.**

Probe easily penetrates end of Termite damaged beam

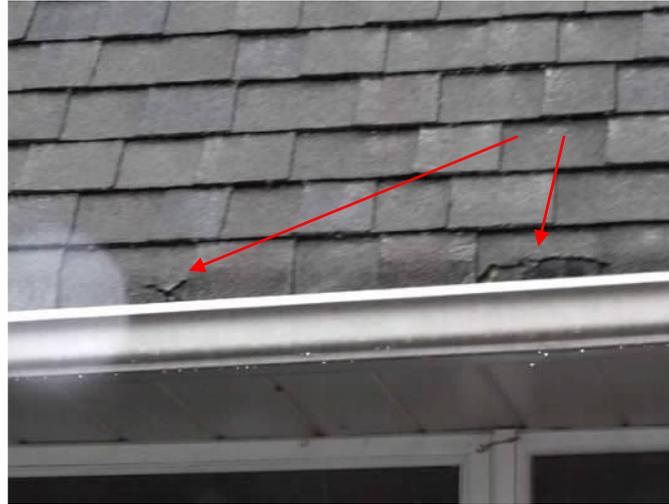
- **Roof shingles appeared to have moderate wear in most areas.**
- **Roof shingles appeared to have significant wear in some areas such as lower roof edges where shingles are worn and cracked.**

Worn and cracked lower sections of shingles

- **Because of the adverse roof conditions noted above, I recommend that a qualified roofer further evaluate the roof to determine the full extent of wear and / or leakage, and make repairs or replacements as necessary to ensure long term leak free condition.**

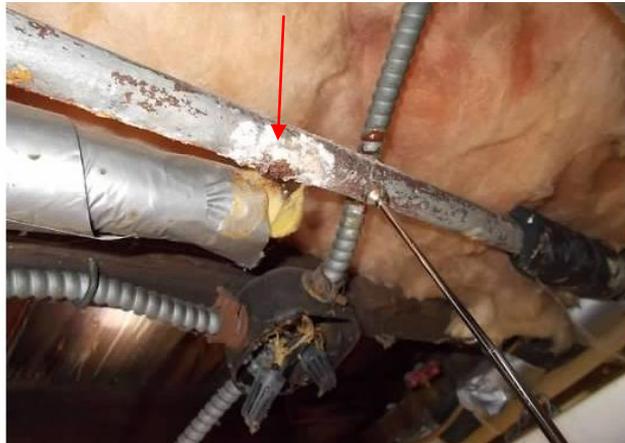
- could leak or otherwise fail without warning.
- One section of old iron water supply pipe *was seen to be actively leaking.*

Corroded and leaking old iron water supply pipe

- Have a plumber further evaluate the water main and main water shutoff valve and repair or replace it as necessary to assure reliable function. Replacement of the iron water main may be found to be advisable.
- Have a plumber repair or replace water supply shutoff valves that exhibit visible corrosion or have signs of leakage.
- Have a plumber replace all remaining sections of old iron water supply pipe.
- Have a plumber evaluate and replace as necessary all sections of aging iron drain pipe.
- To determine the true condition of the waste and drain pipes we recommend that a plumber inspect them internally using a specialized video camera.

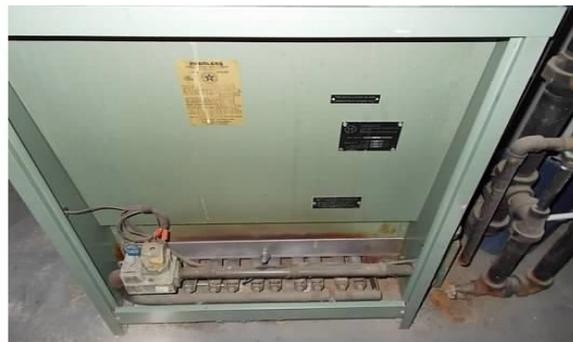
- **The heating components are approaching the end of designed service life, and remaining service life is undeterminable by us. In addition, for old equipment, the possibility of hidden internal functional and safety related defects is significantly increased.**
- **Significant visible corrosion and heat scorching present, which suggests hidden defects.**

Aging steam heating system

- **Replacement of this old heating system with new equipment. This work should be done by a qualified and licensed heating contractor. If replacement is not immediately done, I recommend further evaluation of the heating system components by a qualified specialist to assure that hidden defects or safety related issues are not present.**
- **Monitor radiators and radiator connections for leakage, and have any leaks repaired promptly.**
- **A service contract to cover future maintenance and repairs to the heating system.**
- **See the Chimney section of this report for more information.**

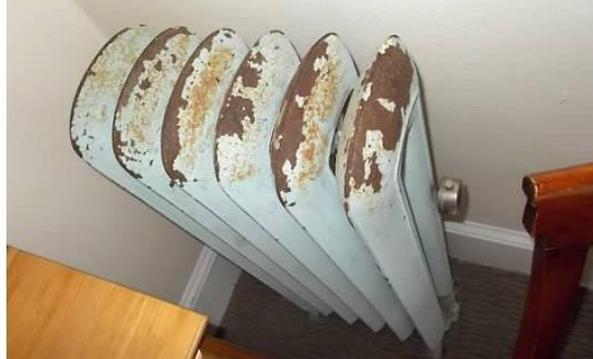
Wall and Ceiling Condition: In most areas, generally functional – only minor repairable defects. **Several small cracks are present in the ceiling on the second floor. Paint on radiators is worn and / or peeling. This can pose a lead paint hazard.**

Peeling paint on radiator

- **Have a qualified painter repair and repaint hairline cracks on the ceiling.**
- **Have a qualified contractor professionally remove loose paint from radiators and repaint.**
